Yellow Flag NB2222W012

BIN: 1065318

Feature Carried: 278I278IX2M23027

Feature Crossed: 6TH AVENUE

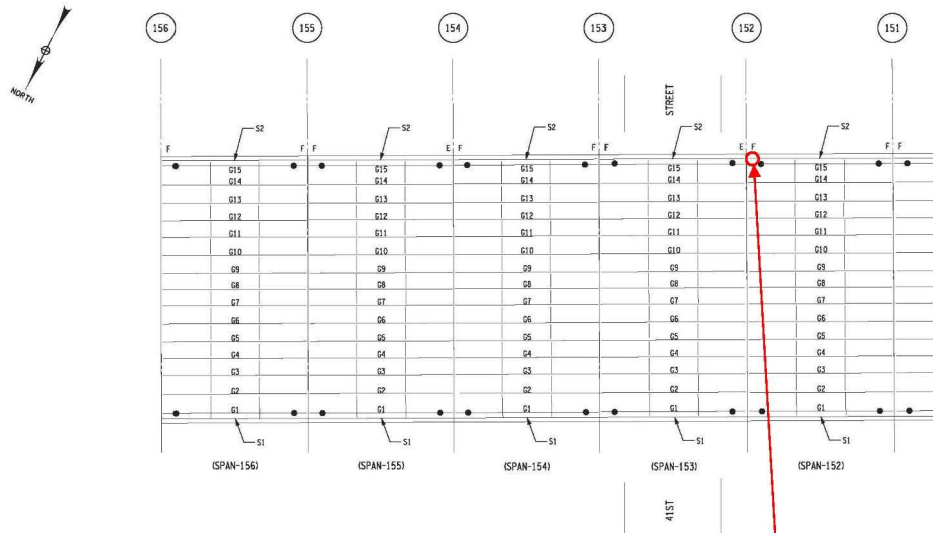
Photo Number: 1

**YELLOW FLAG
LOCATION**
No. NB2222W012

Attachment Description: SN 152 - S2 at Pier 152 Framing Plan

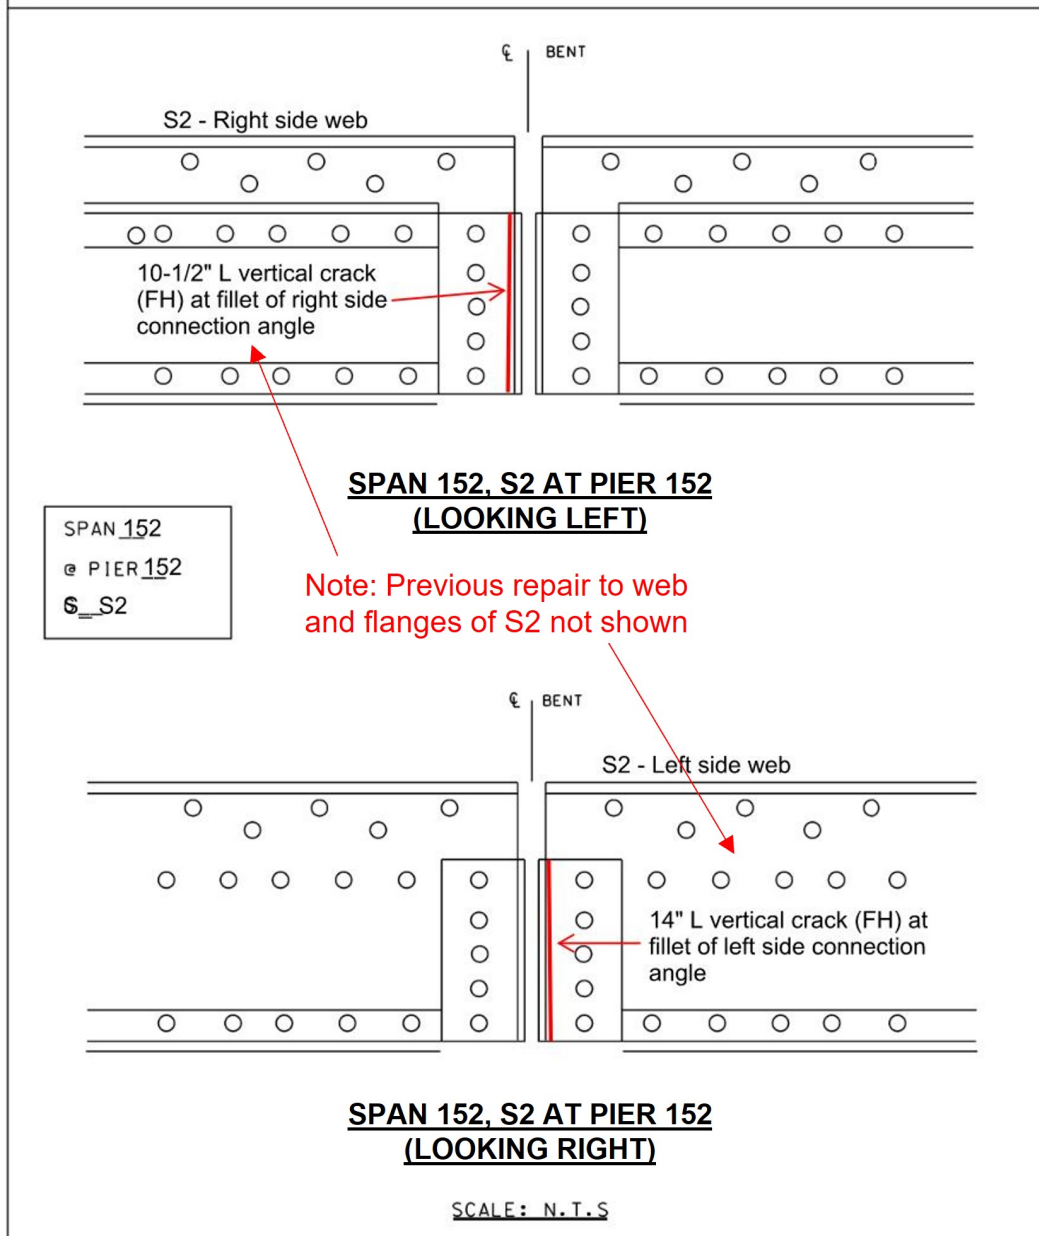
Photo Number: 2

**Attachment Description: SN 152 - S2 at Pier 152 Sketch**

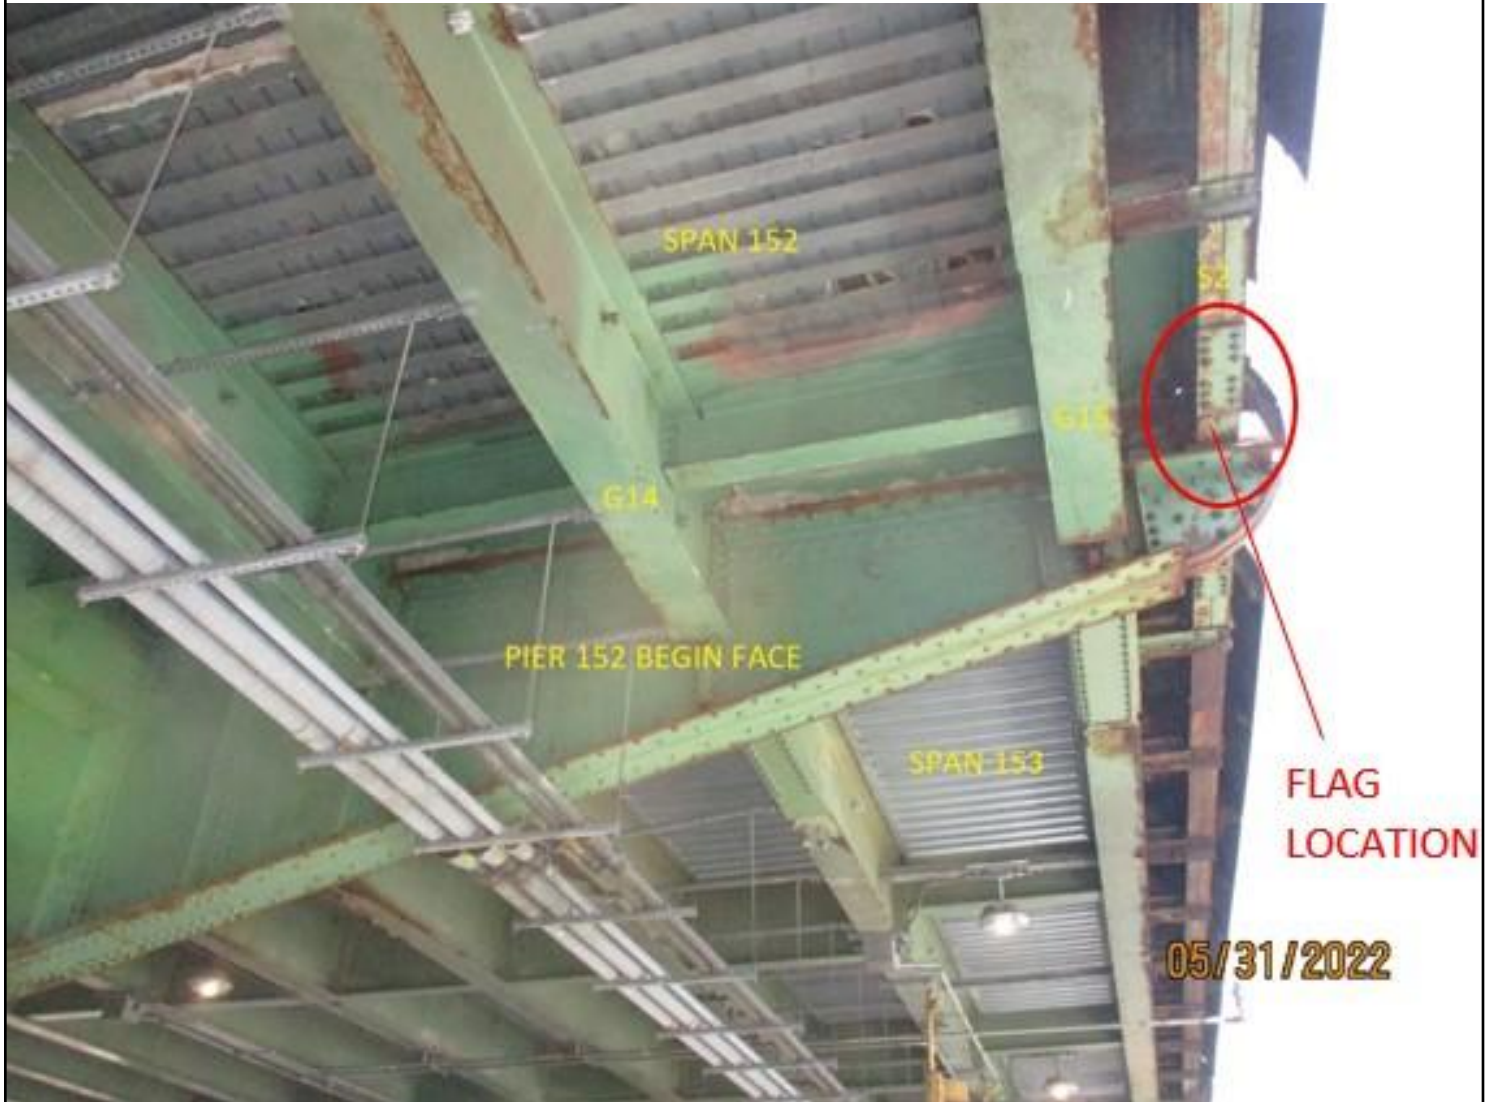
Photo Number: 3

Attachment Description: Photo 1: General view of Flag location at Pier 152. Looking end.

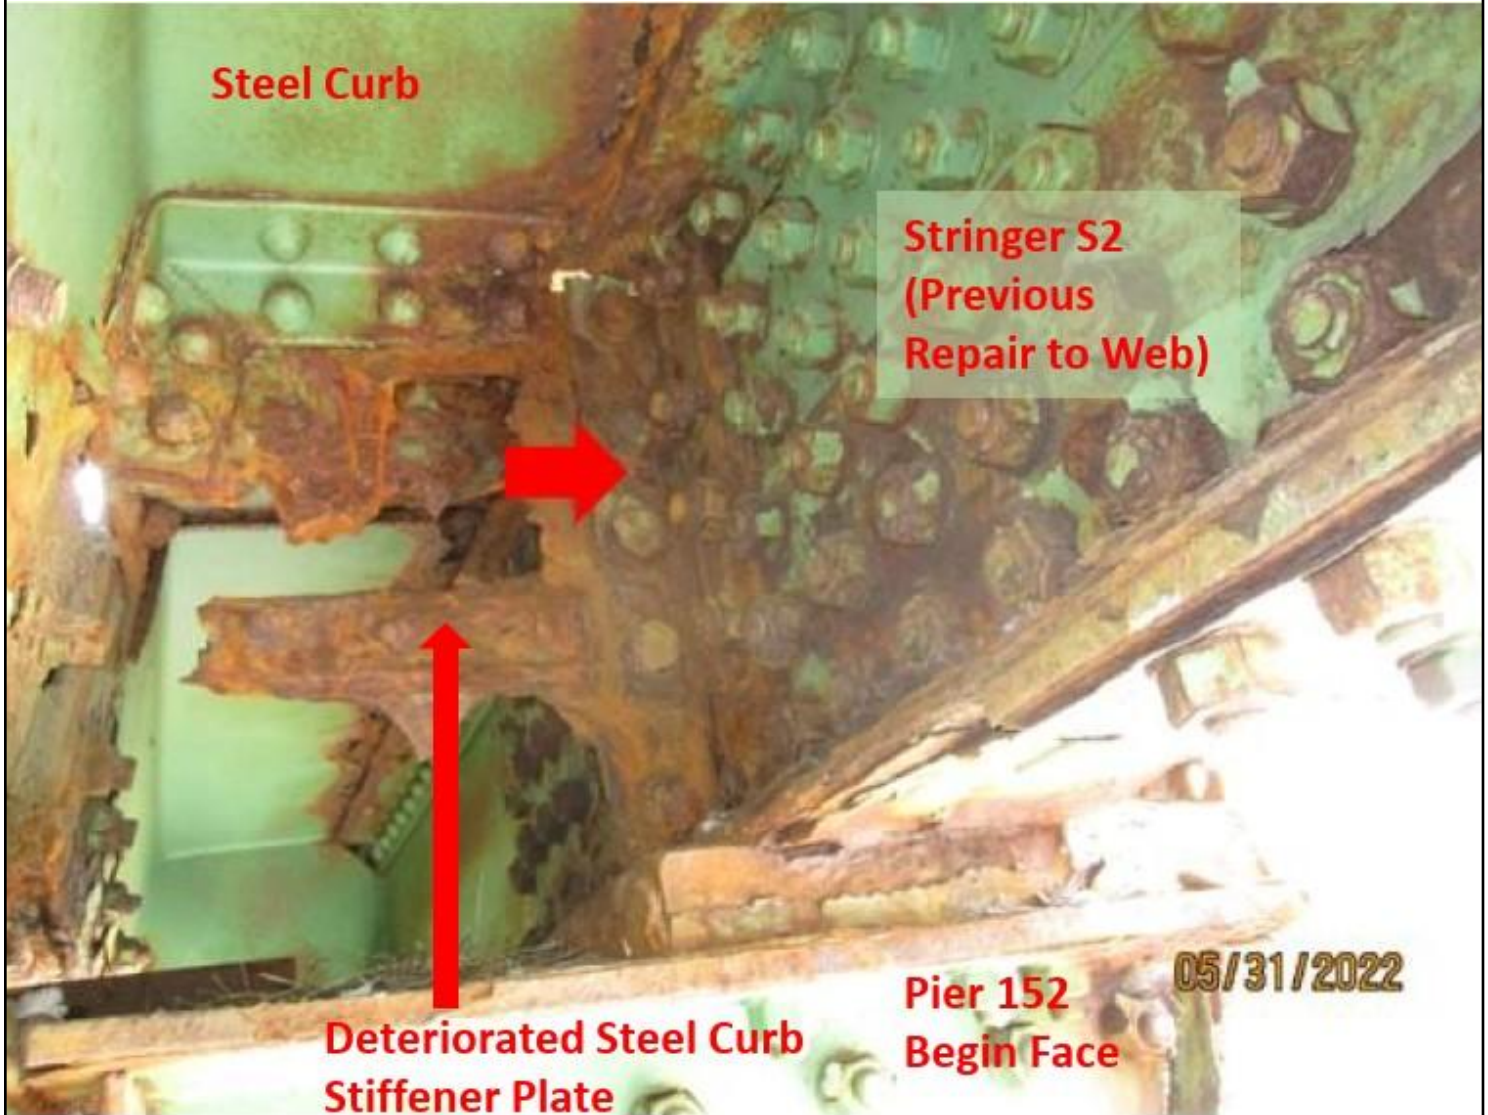
Photo Number: 4

Attachment Description: Photo 2: Span 152, Stringer S2 at Pier 152 - General view at left side of Stringer S2. Looking end. (Arrow is pointing at the full height vertical crack in left connection angle - See next photo).

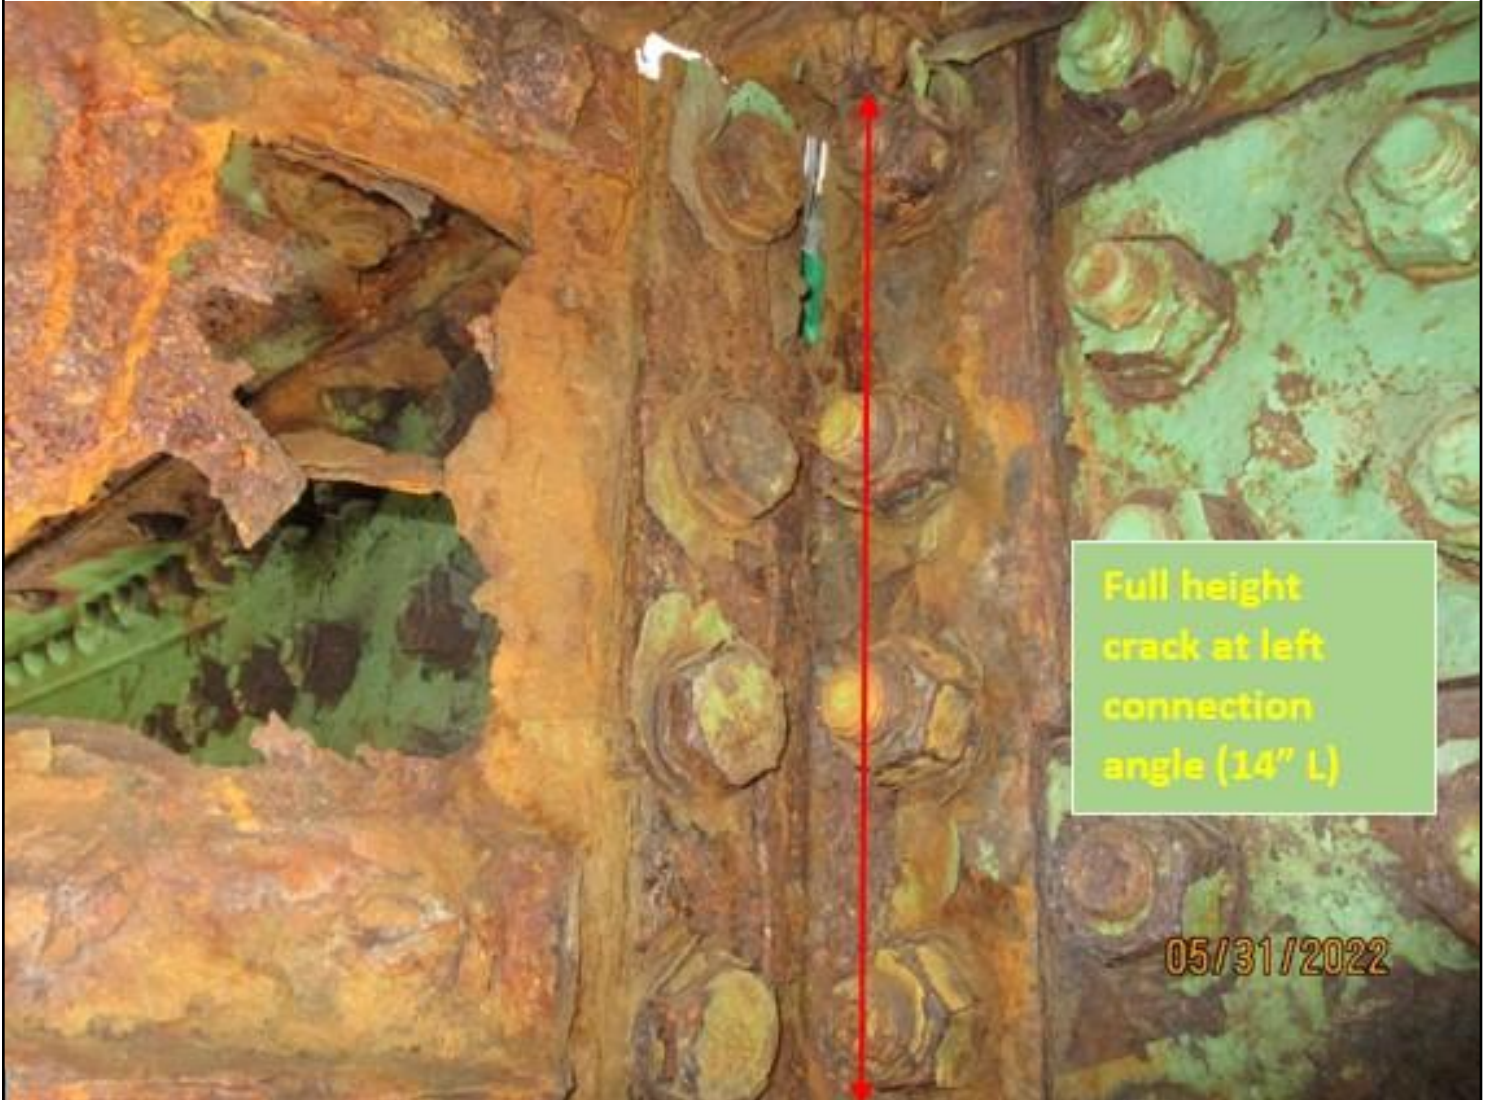
Photo Number: 5

Description: Both connection angles of Stringer S2 to the begin face of the Pier Cap at Pier 152 are cracked. The right connection angle at Stringer S2 at the begin face of the Pier Cap at Pier 152 exhibits a full height vertical crack (10-1/2" L) at the fillet. The left connection angle has a full height vertical crack (14" L) at the fillet.

Attachment Description: Photo 3: Span 152, Stringer S2 at Pier 152 - Full height vertical crack at left connection angle at fillet (14"L). Looking end right.

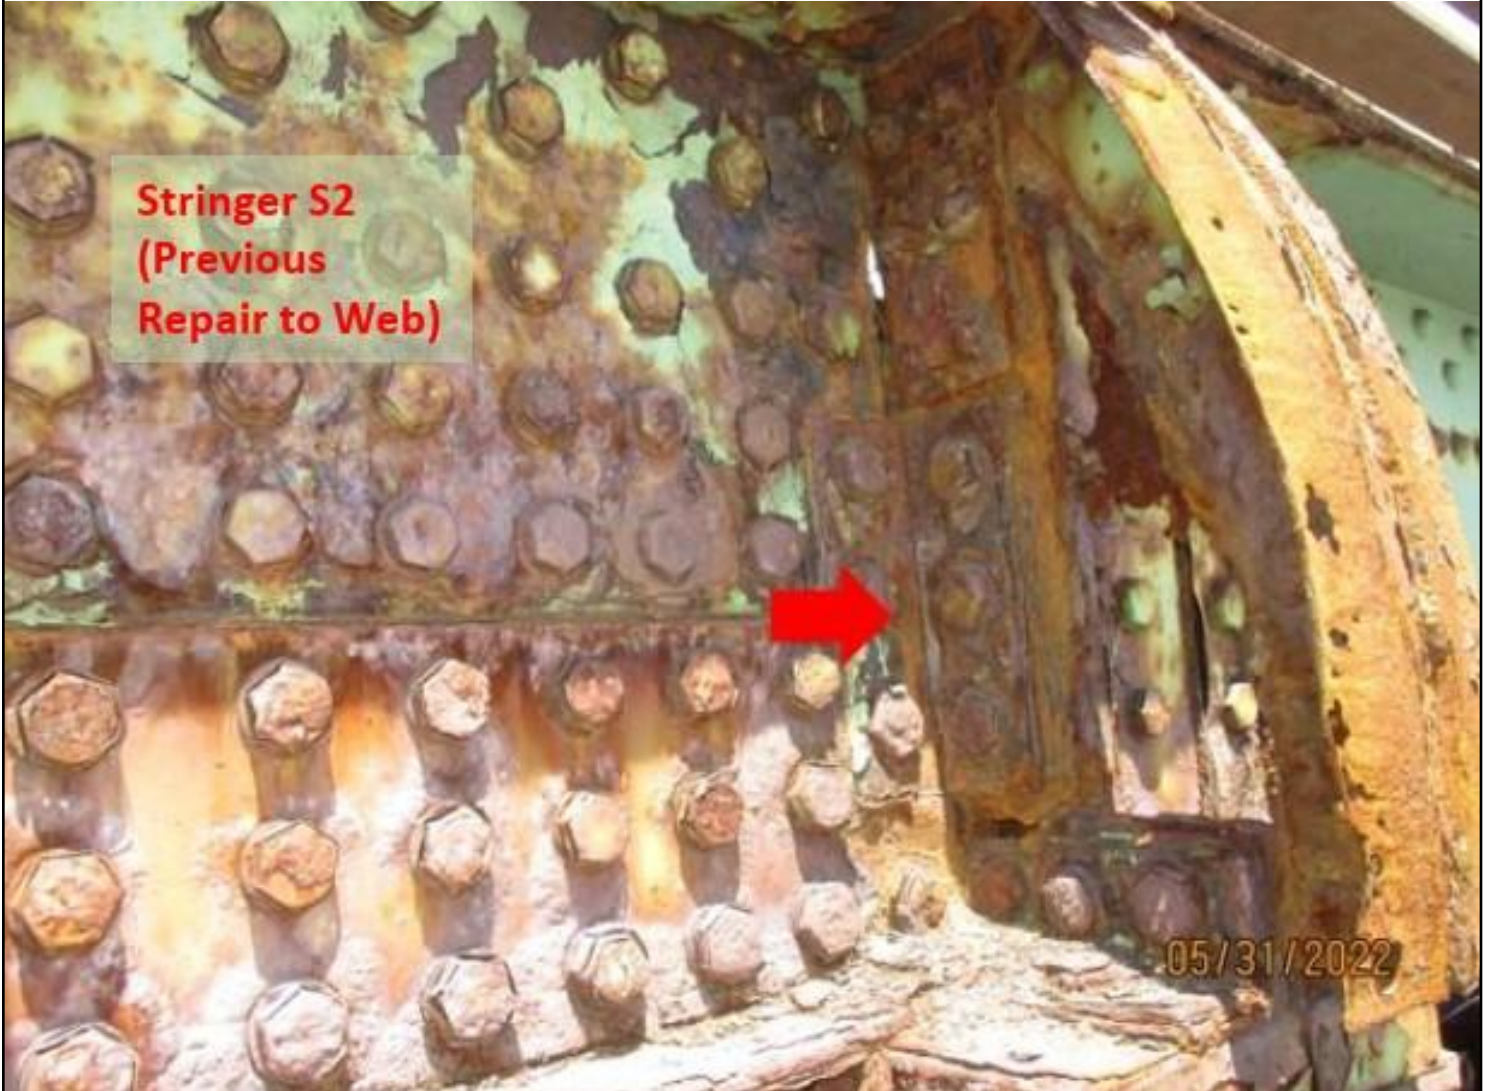
Photo Number: 6

Attachment Description: Photo 4: Span 152, Stringer S2 at Pier 152 - General view at right side of Stringer S2. Looking end left. (Arrow is pointing at the full height vertical crack in the right connection angle - see next photo).

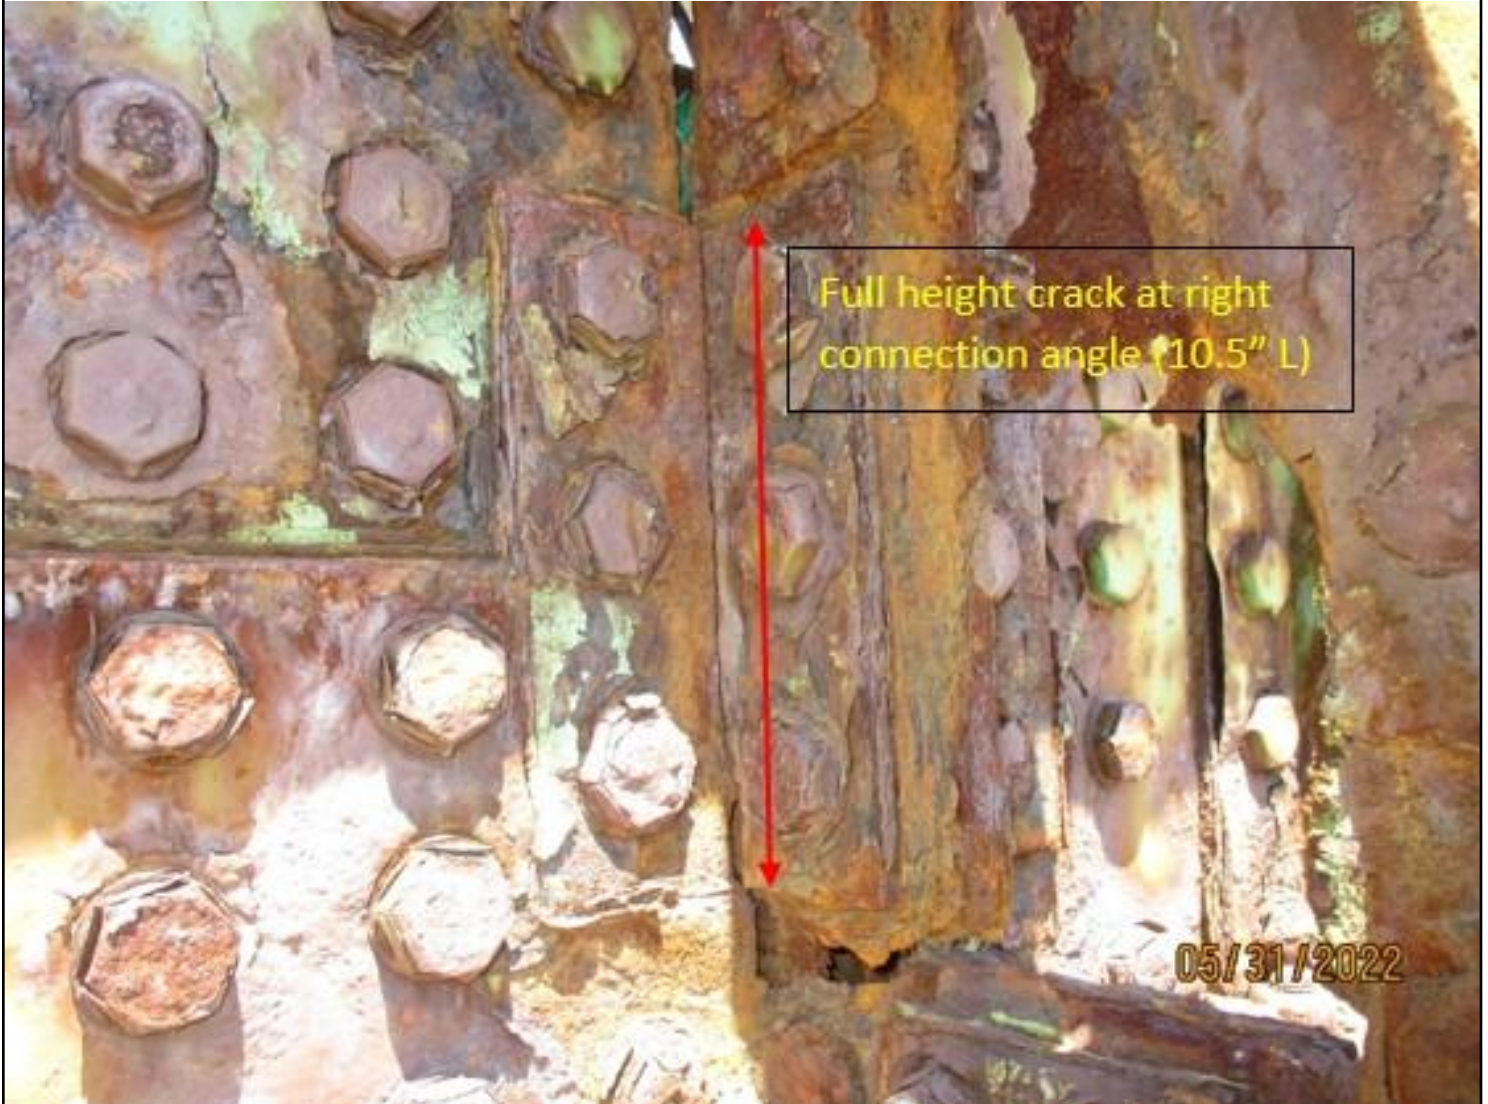
Photo Number: 7

Attachment Description: Photo 5: Span 152, Stringer S2 at Pier 152 - Full height vertical crack at right connection angle at fillet (10.5"L). Looking end left.
